OPERATING EXPERIENCE WEEKLY SUMMARY

Office of Nuclear and Facility Safety

December 18 - December 24, 1998

Summary 98-51

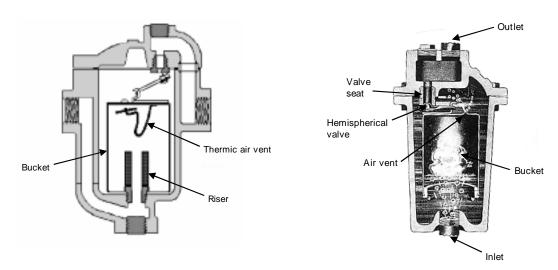
On December 4, 1998, at the West Valley Site, a facility manager reported that an Armstrong 880T steam trap was improperly assembled, affecting its operation. The internal configuration of the trap incorrectly included a riser that interfered with the proper operation of a thermic bucket that controls the release of air and water from the trap. Facility personnel contacted the trap manufacturer about the as-found configuration. The manufacturer agreed that the configuration of the trap was improper and that one of its distributors may have taken its parts and assembled them improperly. This event is important because proper steam trap operation is crucial in preventing condensate-induced water hammer, which can damage equipment and injure personnel. (OH-WV-WVNS-WVNSGEN-1998-0001)

Operators at the West Valley Site found the steam trap not functioning following restart from a system outage. Believing the line was plugged they flushed and drained it, with no success. Mechanics disassembled the trap, removed some debris, and returned it to service. The trap still did not function correctly and was disassembled a second time. A system engineer then found that the trap was equipped with a riser that interfered with the operation of the thermic bucket. The thermic bucket is an inverted bucket that includes a bimetallic (thermostatic) controlled auxiliary air vent for discharging large amounts of air on start-up of the system. The buildup of air inside the inverted bucket can interfere with trap operation. The riser is designed to help with the efficiency of the steam trap when a normal bucket is installed. A normal bucket has a small vent in its top that allows air to escape. Figure 1-1 shows the configuration of the 880T steam trap with the thermic bucket and the installed riser. Figure 1-2 shows the configuration of a typical inverted bucket trap with a normal bucket.

Figure 1-1. Steam Trap With Riser

Figure 1-2. Inverted Bucket Trap (Courtesy of Armstrong Machine Works)

The proper operation of steam traps is important for the safe and efficient operation of process and heating steam systems. DOE/EH-0560, Safety Notice 98-02, *Water Hammer*, recommends (1) walking down steam systems and checking for proper location, distribution, and sizing of steam traps, (2) inspecting steam traps frequently for proper operation, and (3) verifying traps are on-line during system start-up and during system operation. Operators at the West Valley Site check steam trap operation frequently and use thermal imagery (infrared heat gun) to help verify proper operation. The Safety Notice on water hammer can be obtained by contacting the ES&H Information Center, (800) 473-4375, or by writing to U.S. Department of Energy, ES&H Information Center, EH-72, 19901 Germantown Rd., Germantown, MD 20874. Safety Notices are also available at http://tis.eh.doe.gov:80/web/oeaf/lessons_learned/ons/ons.html.
